Manhole Inspection Summary

Manhole # S15G__031MH

Insp Date: **6/23/09 3:52 PM**

Location Address: **N. FRANKLINTOWN RD**

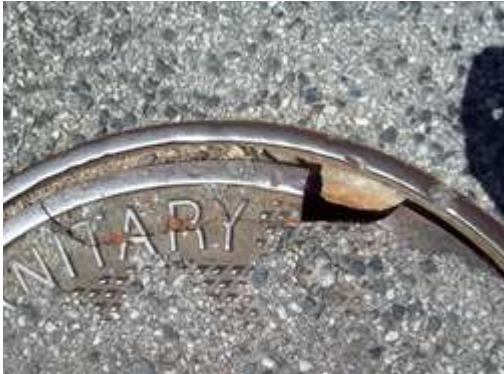
Defect 1

Cannot Access - Cracked Cover

Comments **MH LID CRACKED. COULD NOT OPEN.**

BROKEN MH LID
